INSPECTION REPORT

TITLE	W501D5 GAS TURBINE UNIT ROTOR INSPECTION		
OWNER	EMISSIONS GROUP	PERIOD	2016. 07. 18 ~ 08. 30
EQUIPMENT	W501D5 GT Unit Rotor	Service Order No.	1608001

2016. 08. 23

W501D5 GAS TURBINE UNIT ROTOR INSPECTION REPORT

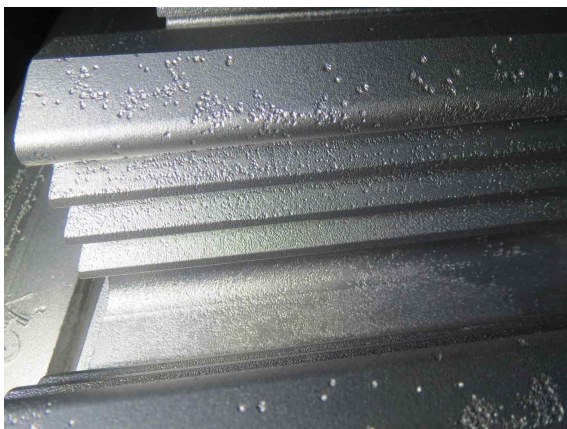
Figure 4. Row 1 Dovetail Pitting

4.2 After performing MT for Turbine Disc in each rows, linear crack indication was not found but pitting damages were presented throughout the surface of the Dovetail as seen in the figure 4 and 5.

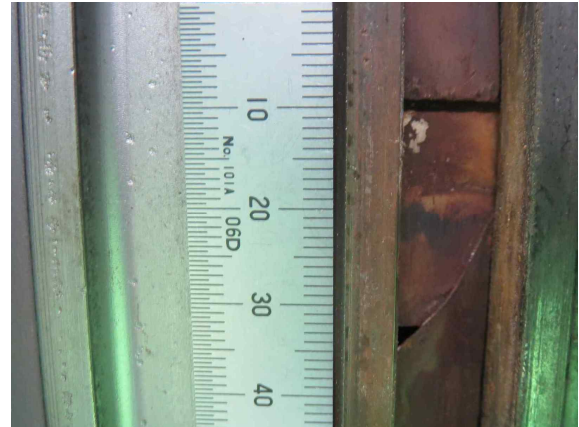
Figure 7. Row 1-2 Belly Band Fracture

- 4.3 MT and VT were performed on Compressor Blades. Linear crack indication was not found but dent and bent damages were found in some of the blades as seen in the Figure 9.
- 4.4 VT was performed on the Turbine Wheel Belly Band and fracture was found on the Row 1-2 Belly Band overlap as seen in the Figure 7.
- 4.5 NDT Report : See the Attachment 1.

- Rusts and deposits on the Rotor were removed through Rotor Blast cleaning after withdrawing the turbine side blades in the 1~4 rows.
- NDT(MT & VT) was done for the Turbine side and the Compressor side. The results show that for Turbine Disc, there were damages in Belly Band at row 1-2 and the pitting damages on the surface of Dovetail. For the Compressor Blades, dents and bents were found that can be repaired.

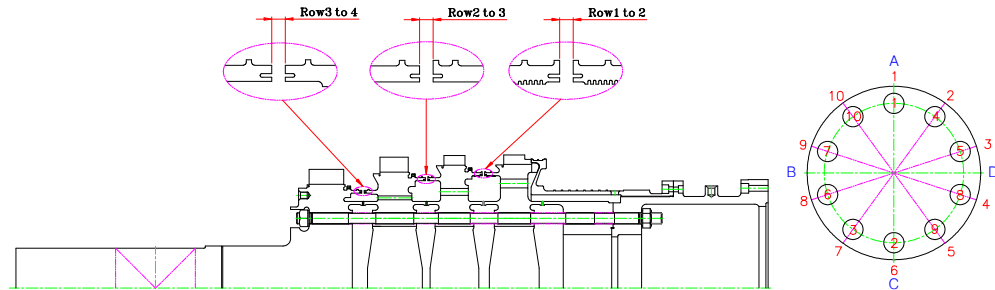
Figure 10. Turbine Disc Gap Measurement Position

- 5.1 Set up the Unit Rotor on the Balancing Machine.
- 5.2 Turbine Disc Gap was measured to check Turbine Disc Curvic Clutch Teeth wearing out and Spindle Bolts looseness using Block Gage.
- 5.3 The results of Turbine Disc Gap measurement for each rows are tabulated in the Table 1, and no abnormality was found.

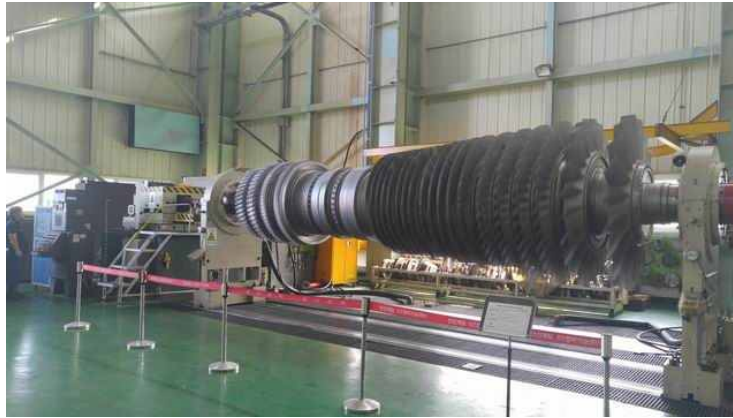
Figure 13. Unit Rotor Shop Balancing

- 8.1 After having enough Bow Out procedure, the Unit Rotor without the Turbine Blades was rotated at 250 RPM and the measured Initial Total Unbalance value was 900 gram, which largely exceeds the permitted value.
- 8.2 Unit Rotor Shop Balancing procedure was performed to reduce the Unbalance value to the permitted value and the result is as found in the Attachment 4.

Planes Values	Plane #1 (Zone E)	Plane #2 (Zone A)
Initial	429g ∠ 344.9°	473g ∠ 307.3°
Final	13.5g ∠ 24.9°	14.4g ∠ 341.6°
Final Weight Mapping	-Zone A : 170g ∠ 286°(#10), -Zone B : 158g ∠ 325° -Zone C : 158g ∠ 324°(#9), -Zone D : 170g ∠ 322°(#6) -Zone E : 214g ∠ 7°(#1)

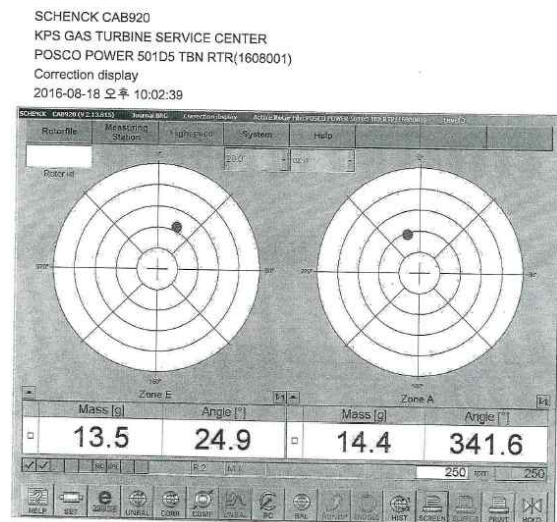
Figure 15. Final Unbalance Values

- Unbalance value of the rotor was measured under the Spool state where the Turbine Blades are withdrawn. There was a great difference between the measured values and the permitted values but the unbalance was corrected within the permitted range after performing the Shop Balancing.

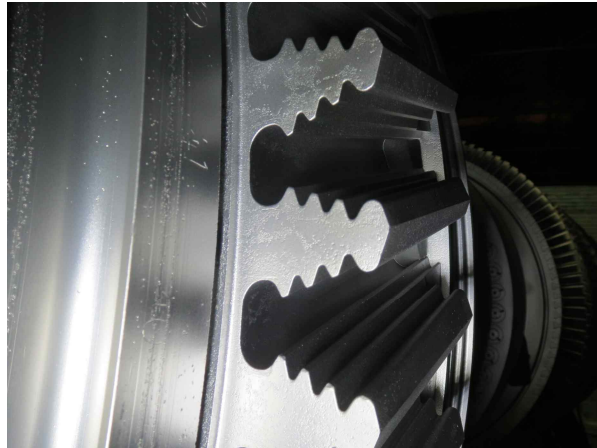
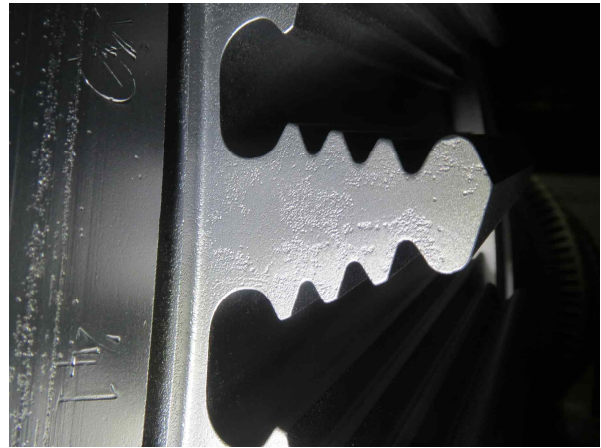
Fig. 10. Row 1 Wheel dovetail - Pitting

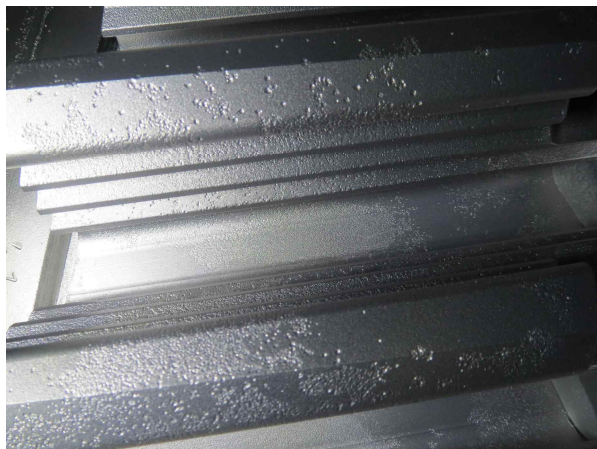
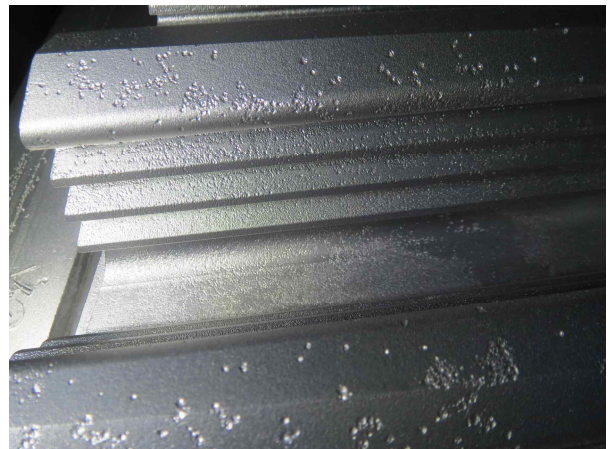
Fig. 11. Row 1 Wheel dovetail - Pitting

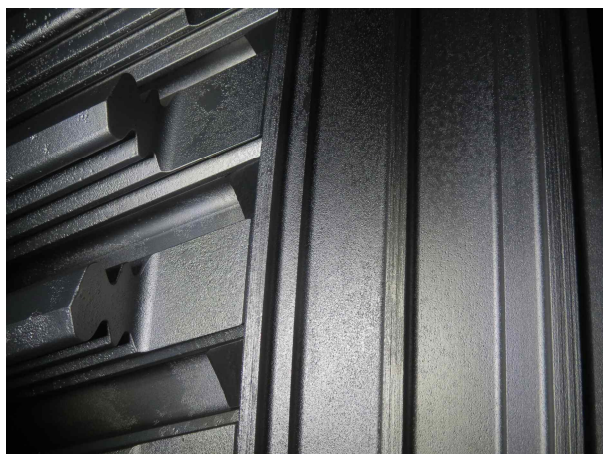
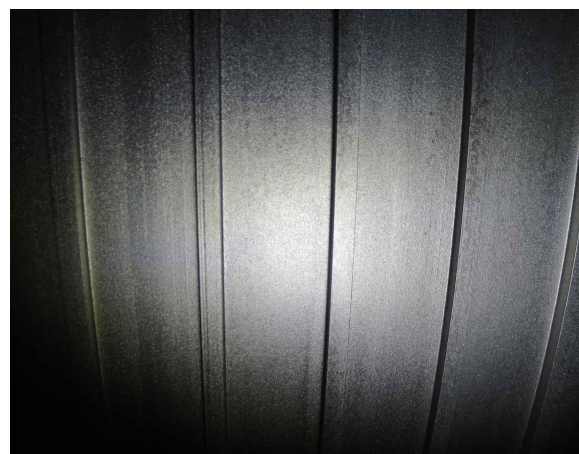
Fig. 12. Row 1 Wheel dovetail - Pitting

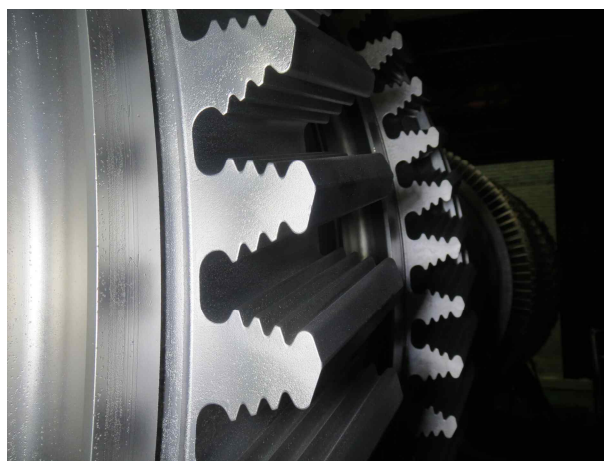
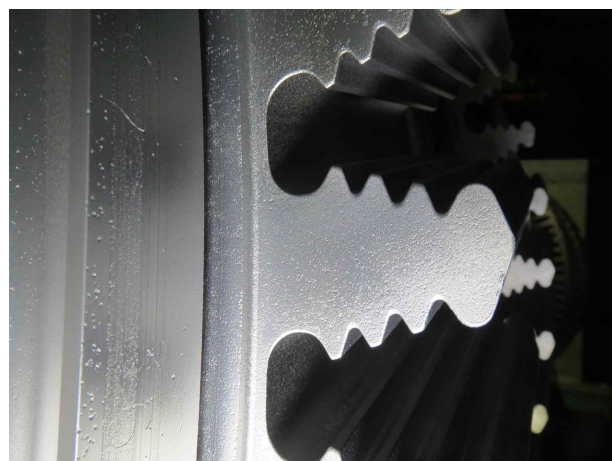
Fig. 13. Row 2 Wheel dovetail - Pitting

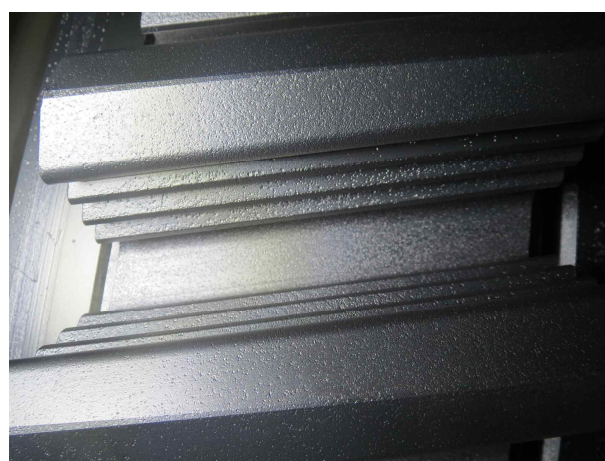
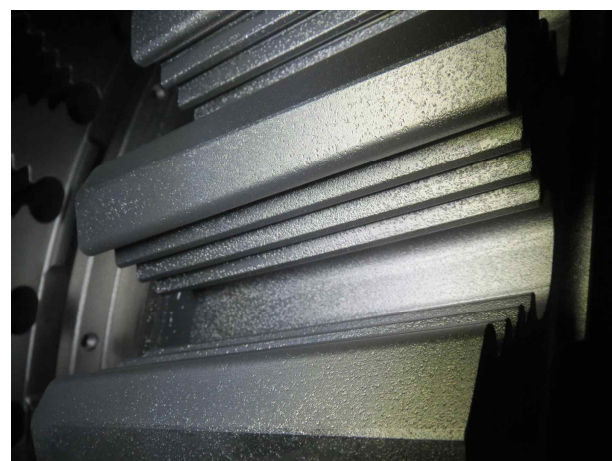
Fig. 14. Row 2 Wheel dovetail - Pitting

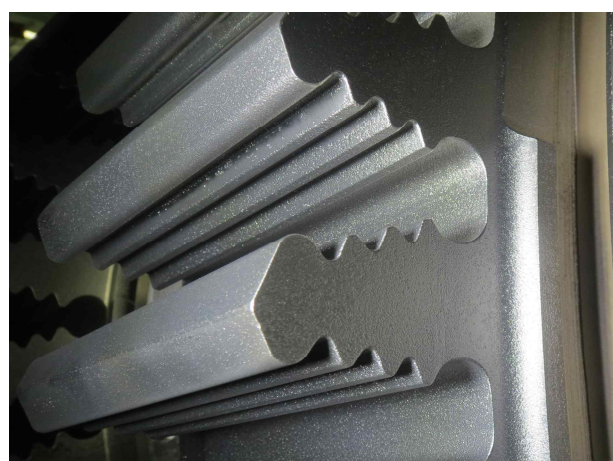
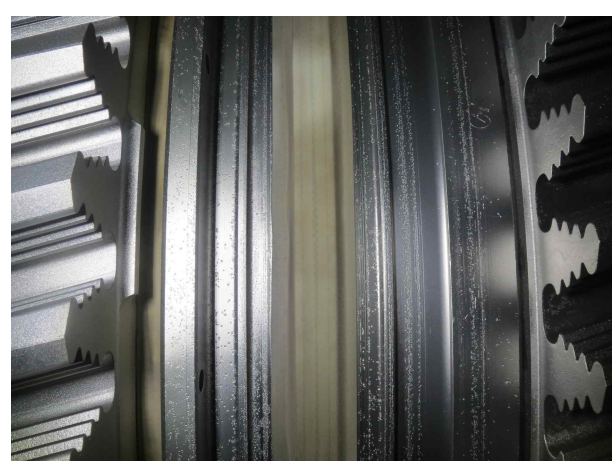
Fig. 15. Row 2 Wheel dovetail - Pitting

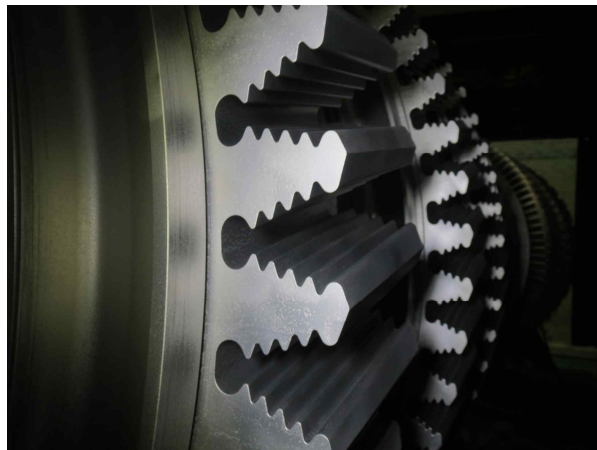
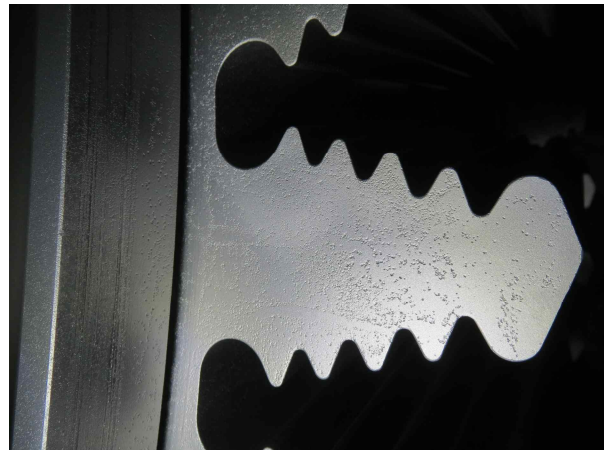
Fig. 16. Row 3 Wheel dovetail - Pitting

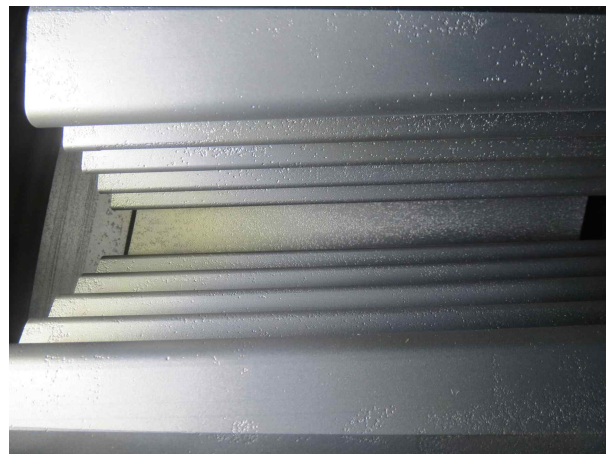
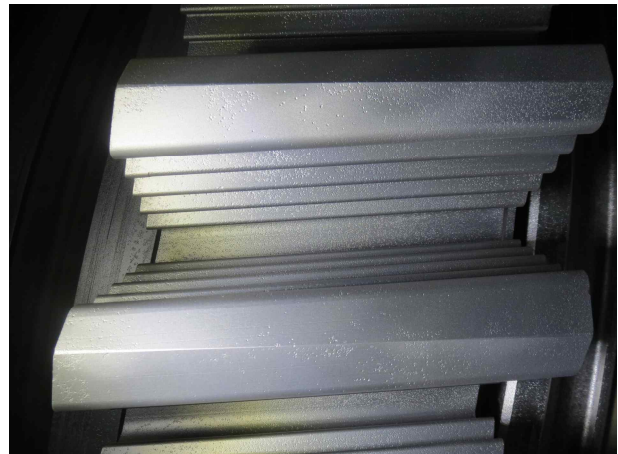
Fig. 17. Row 3 Wheel dovetail - Pitting

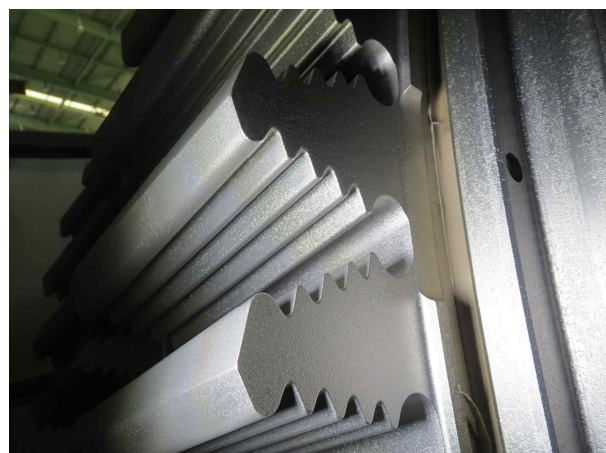
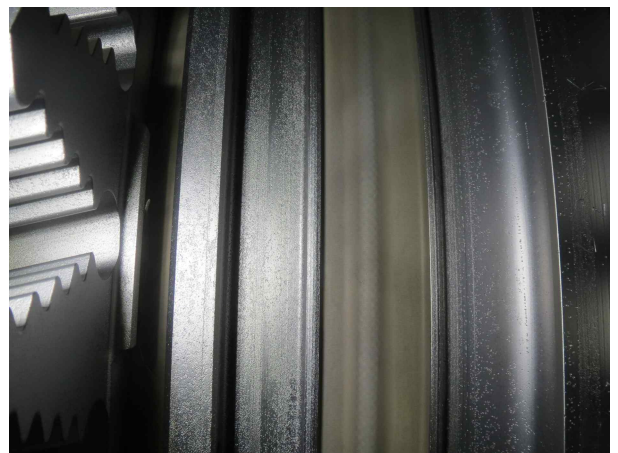
Fig. 18. Row 3 Wheel dovetail - Pitting

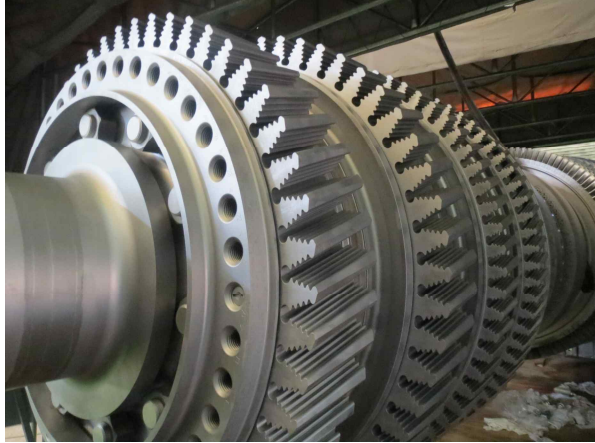
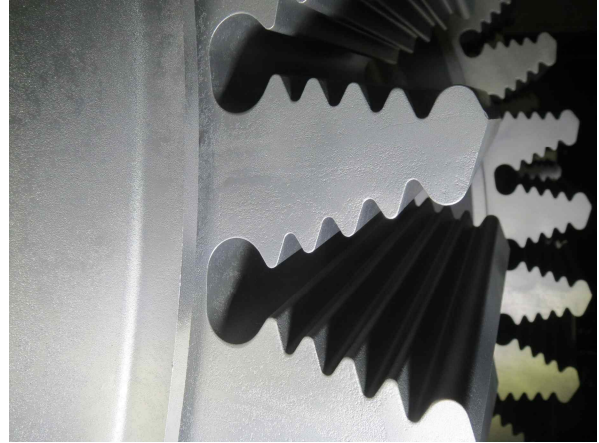
Fig. 19. Row 4 Wheel dovetail - Pitting

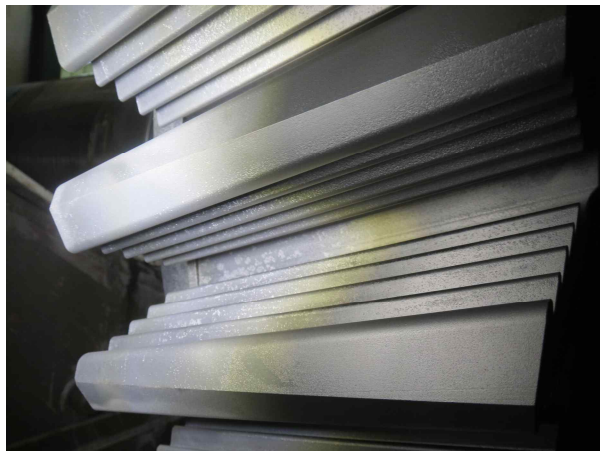
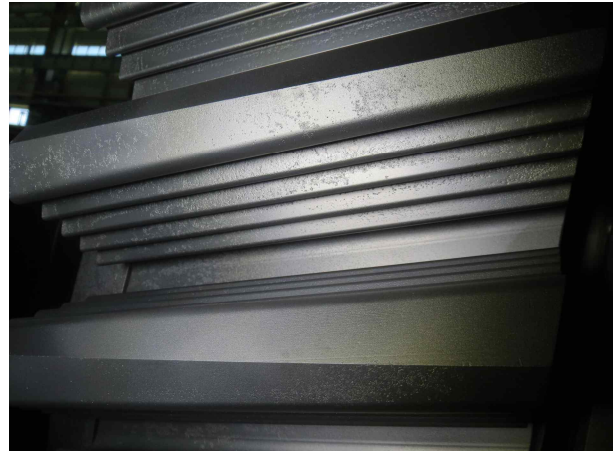
Fig. 20. Row 4 Wheel dovetail - Pitting

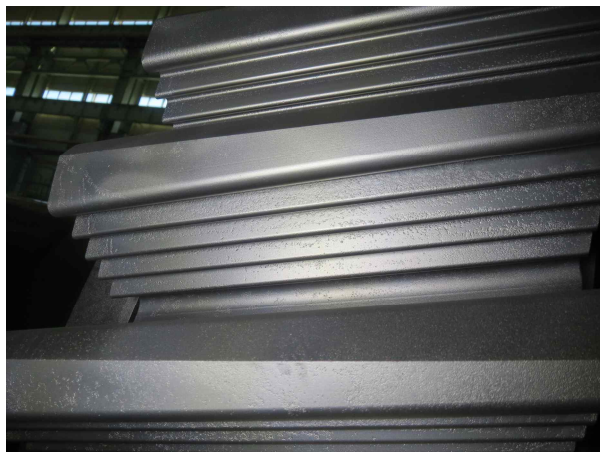
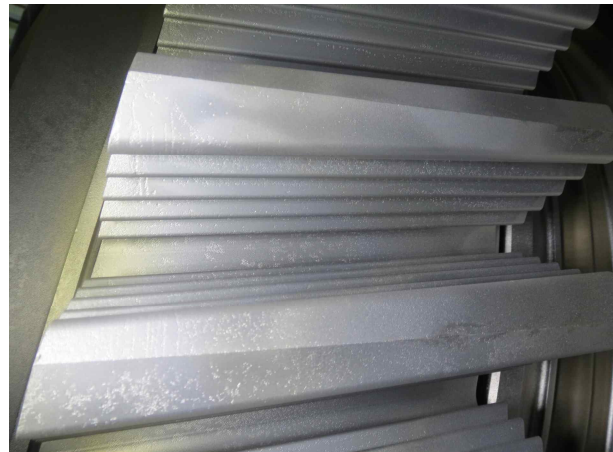
Fig. 21. Row 4 Wheel dovetail - Pitting

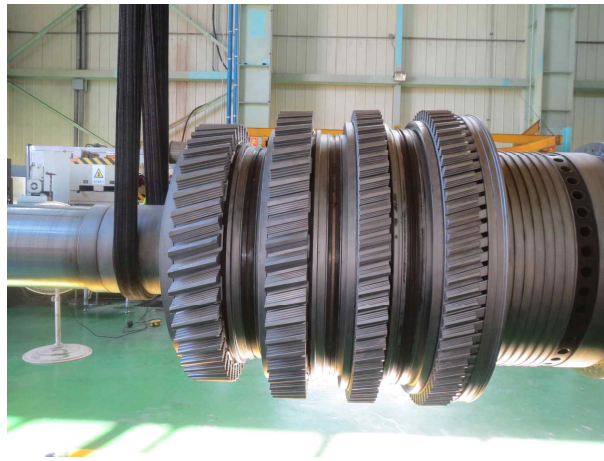
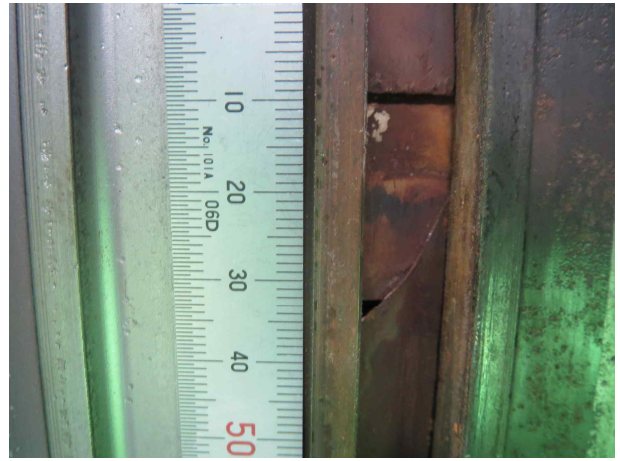
Fig. 22. Row 1 Bally bend - Fracture

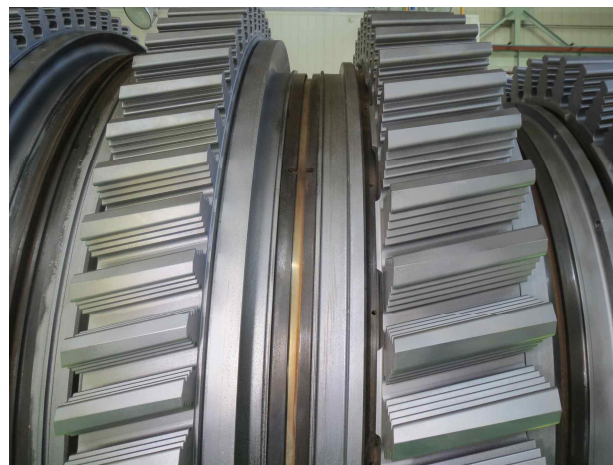
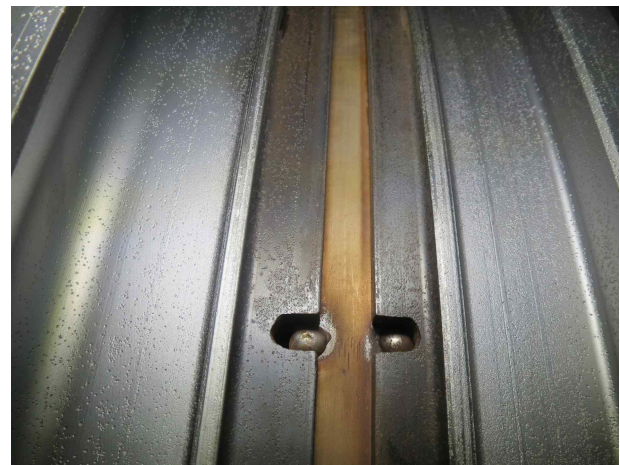
Fig. 23. Row 2 Bally bend - No linear indication

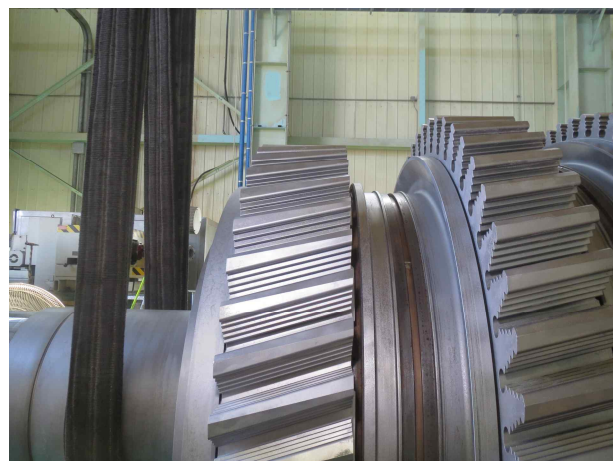
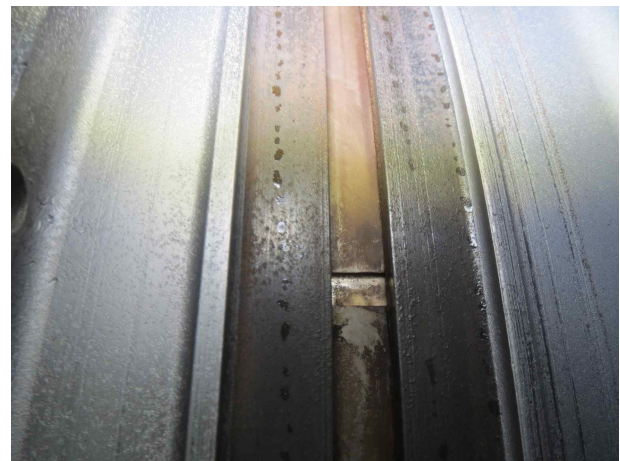
Fig. 24. Row 3 Bally bend - No linear indication

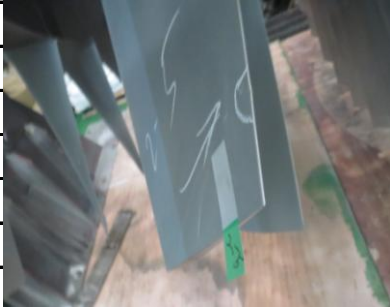
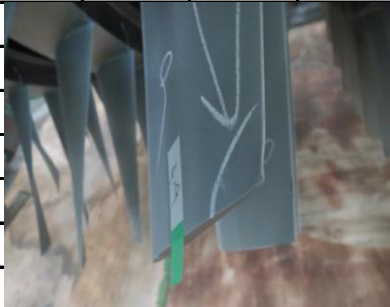
2-5 TE DENT				4-9 TE DENT

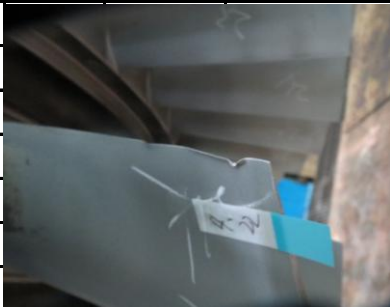
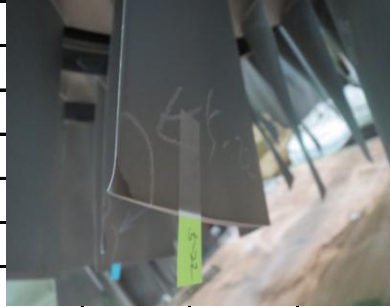
4-22 TE DENT				5-22 TE BENT

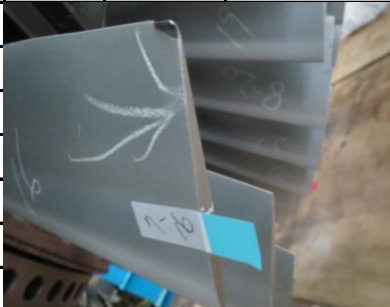
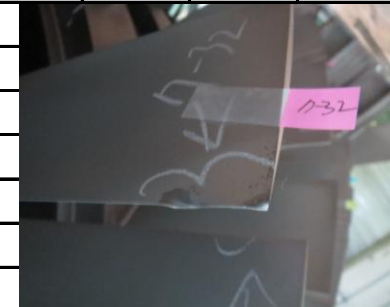
7-16 TE BENT				7-32 TE BENT & DENT
