INSPECTION REPORT

TITLE	W501D5 GAS TURBINE UNIT ROTOR INSPECTION		
OWNER	EMISSIONS GROUP	PERIOD	2016. 07. 18 ~ 08. 30
EQUIPMENT	W501D5 GT Unit Rotor	Service Order No.	1608001

2016. 08. 23

W501D5 GAS TURBINE UNIT ROTOR INSPECTION REPORT

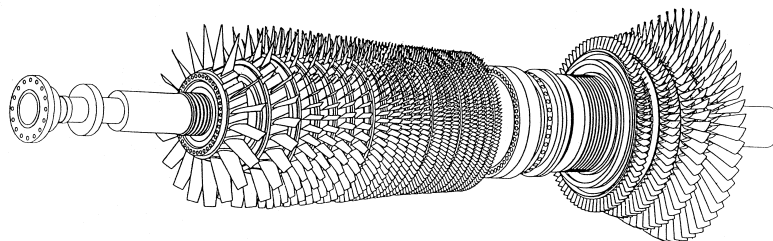
Figure 1. WH W501D5 Unit Rotor

- 1.1 Manufacturer/Model : Westinghouse/W501D5
- 1.2 Rated Capacity / RPM : 100MW / 3600rpm
- 1.3 Stage : Turbine 4 Row, Compressor 19 Row
- 1.4 Recent Major Inspection(Class II B Inspection) : 2007. 03. 14~08.15
- 1.5 Operation Hours : 52,729Hours
- 1.6 Starts/Stops : 3,681

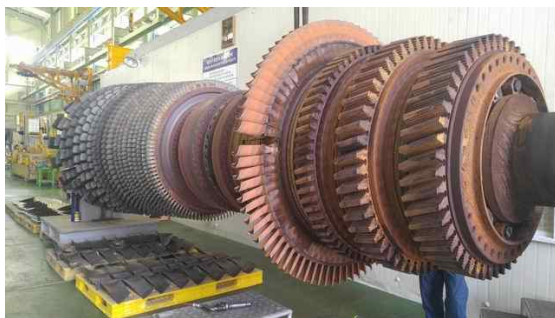
Figure 2. Turbine Blades Withdrawal

- 2.1 Unit Rotor was settled on the stand and Locking Plates of the Turbine Blades were withdrawn.
- 2.2 Turbine Blades in each rows were withdrawn and placed in the separate wooden boxes.

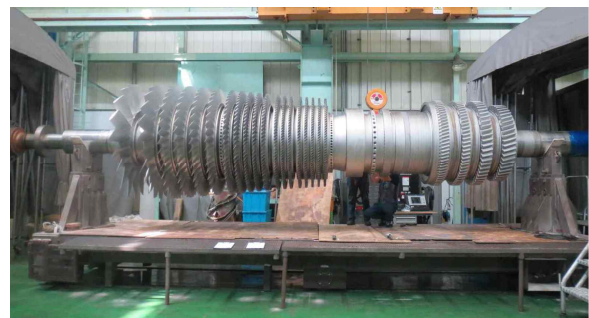
Figure 3. Unit Rotor Blast Cleaning status

3.2 Journal, Thrust Collar and Disc Gap sections were masked before Glass Bead Cleaning procedure.

3.3 Glass Bead Cleaning of the Unit Rotor was performed after moving it to Blasting Room.

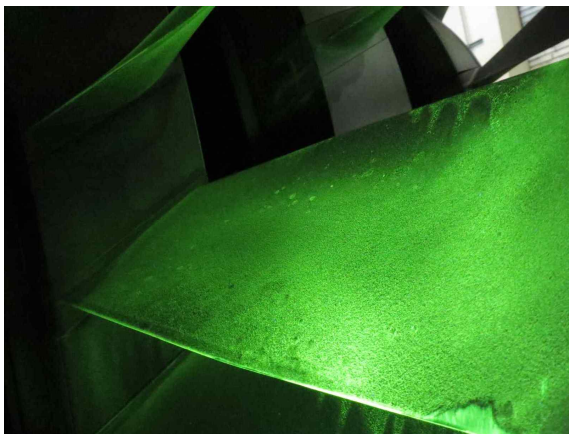
Figure 8. Compressor Blade MT performance

- 4.3 MT and VT were performed on Compressor Blades. Linear crack indication was not found but dent and bent damages were found in some of the blades as seen in the Figure 9.
- 4.4 VT was performed on the Turbine Wheel Belly Band and fracture was found on the Row 1-2 Belly Band overlap as seen in the Figure 7.
- 4.5 NDT Report : See the Attachment 1.

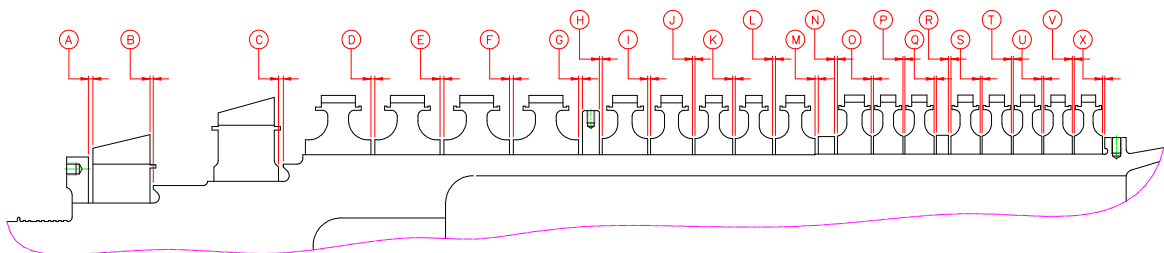
Figure 11. Compressor Disc Gap Measurement Position

6.1 To check the abnormalities of the Compressor Disc's assembling status in each rows, Compressor Disc Gap was measured as tabulated in the Table 2.

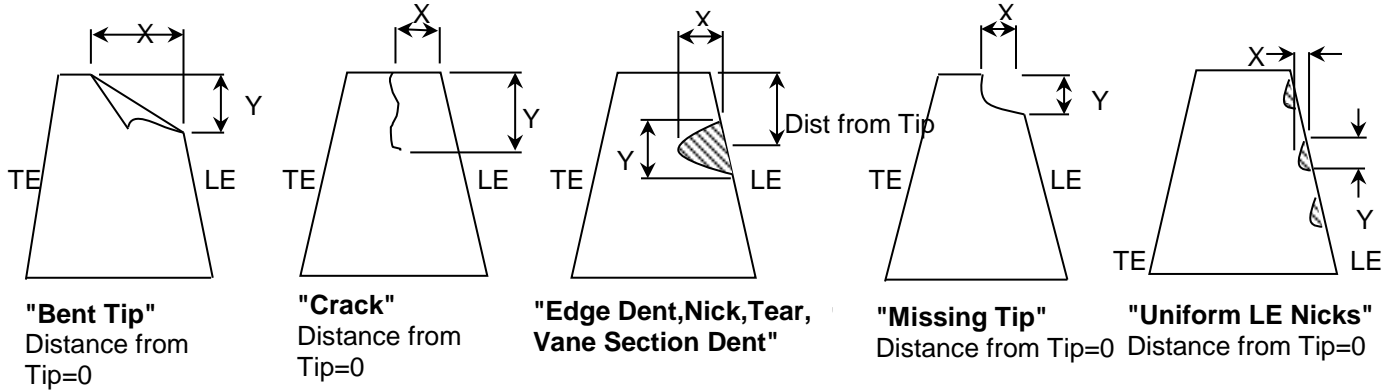
Compressor Blades Mapping

No.	Stage	S/N	Damage Type	Location	Distance from Tip	X	Y	D	Blending Type	Remark
1	2	5	D	TE	35	3	6	-	-	
2	2	19	D	TE	10	2	6	-	-	
3	3	4	D	TE	0	5	5	-	-	
4	3	12	B	TE	0	9	9	-	-	
5	3	18	D	TE	36	3	10	-	-	
6	3	24	D	TE	44	3	10	-	-	
7	3	36	D	TE	212	2	6	-	-	
8	4	7	D	TE	0	12	12	-	-	
9	4	8	D	TE	10	3	5	-	-	
10	4	9	D	TE	0	8	8	-	-	
11	4	12	B	TE	0	12	12	-	-	
12	4	22	D	TE	10	4	22	-	-	
13	4	22	D	TE	46	4	10	-	-	
14	5	6	D	TE	9	2	5	-	-	
15	5	7	D	TE	0	7	7	-	-	
16	5	8	B	TE	0	10	10	-	-	
17	5	12	D	TE	53	3	10	-	-	
18	5	15	D	TE	131	2	10	-	-	
19	5	20	B	TE	0	5	5	-	-	
20	5	22	B	TE	0	9	9	-	-	
21	5	23	D	TE	0	10	10	-	-	
22	5	32	D	TE	0	10	10	-	-	
23	5	33	D	TE	24	2	6	-	-	
24	6	23	D	TE	50	3	10	-	-	
25	6	36	D	TE	0	10	10	-	-	
26	7	16	B	TE	0	10	10	-	-	
27	7	31	D	LE	22	3	10	-	-	
28	7	32	B	TE	0	8	8	-	-	
29	7	32	D	TE	21	3	10	-	-

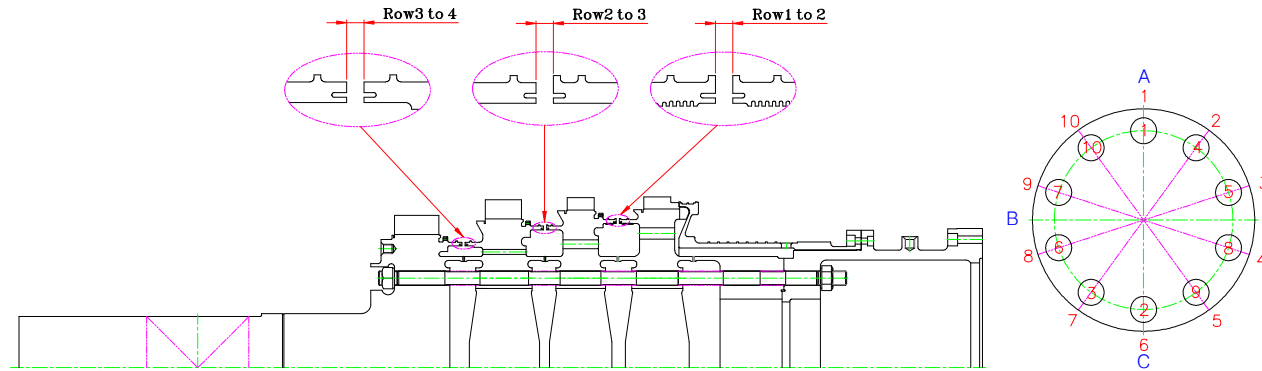
- 5.1 Set up the Unit Rotor on the Balancing Machine.
- 5.2 Turbine Disc Gap was measured to check Turbine Disc Curvic Clutch Teeth wearing out and Spindle Bolts looseness using Block Gage.
- 5.3 The results of Turbine Disc Gap measurement for each rows are tabulated in the Table 1, and no abnormality was found.

Before Loose Spindle Bolt				After Loose Spindle Bolt					
Position		Row 1 to 2	Row 2 to 3	Row 3 to 4	Position		Row 1 to 2	Row 2 to 3	Row 3 to 4
A	0°	12.12	12.26	11.92	A	0°			
B	90°	12.11	12.26	11.95	B	90°			
C	180°	12.10	12.22	11.96	C	180°			
D	270°	12.12	12.24	11.97	D	270°

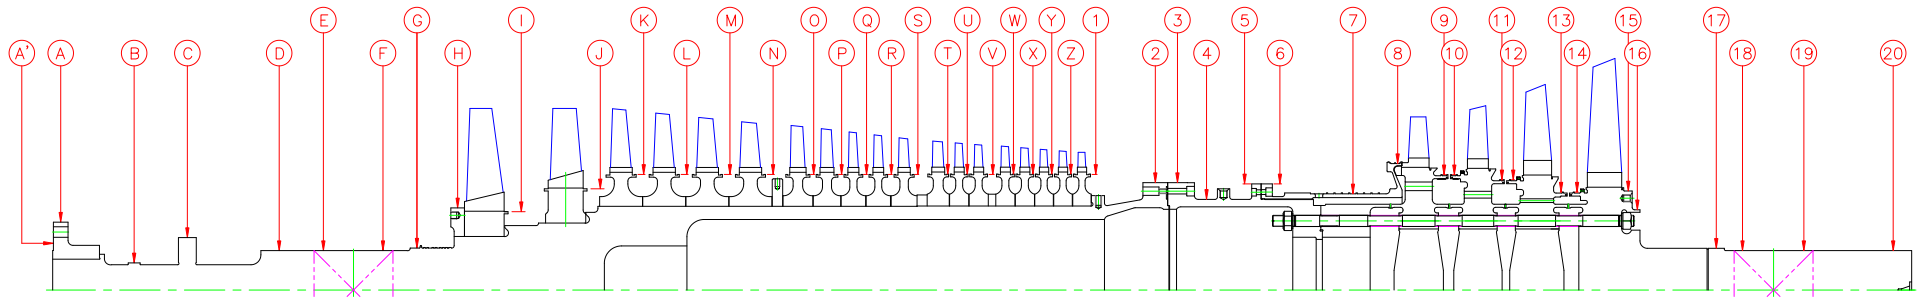
- 7.5 The measured Runout value of the Journal's Sliding Area is in 0.0003~0.0005" which is relatively in a good range.
- 7.6 Runout values for the Compressor Generator Coupling OD and the Face exceed the standard range and correction is needed.

- 7.7 Runout value of Turbine Rotor Journal is 0.0013" and correction is needed.
- 7.8 Unit Rotor Runout Measurement Results Table : See the Attachment 4.

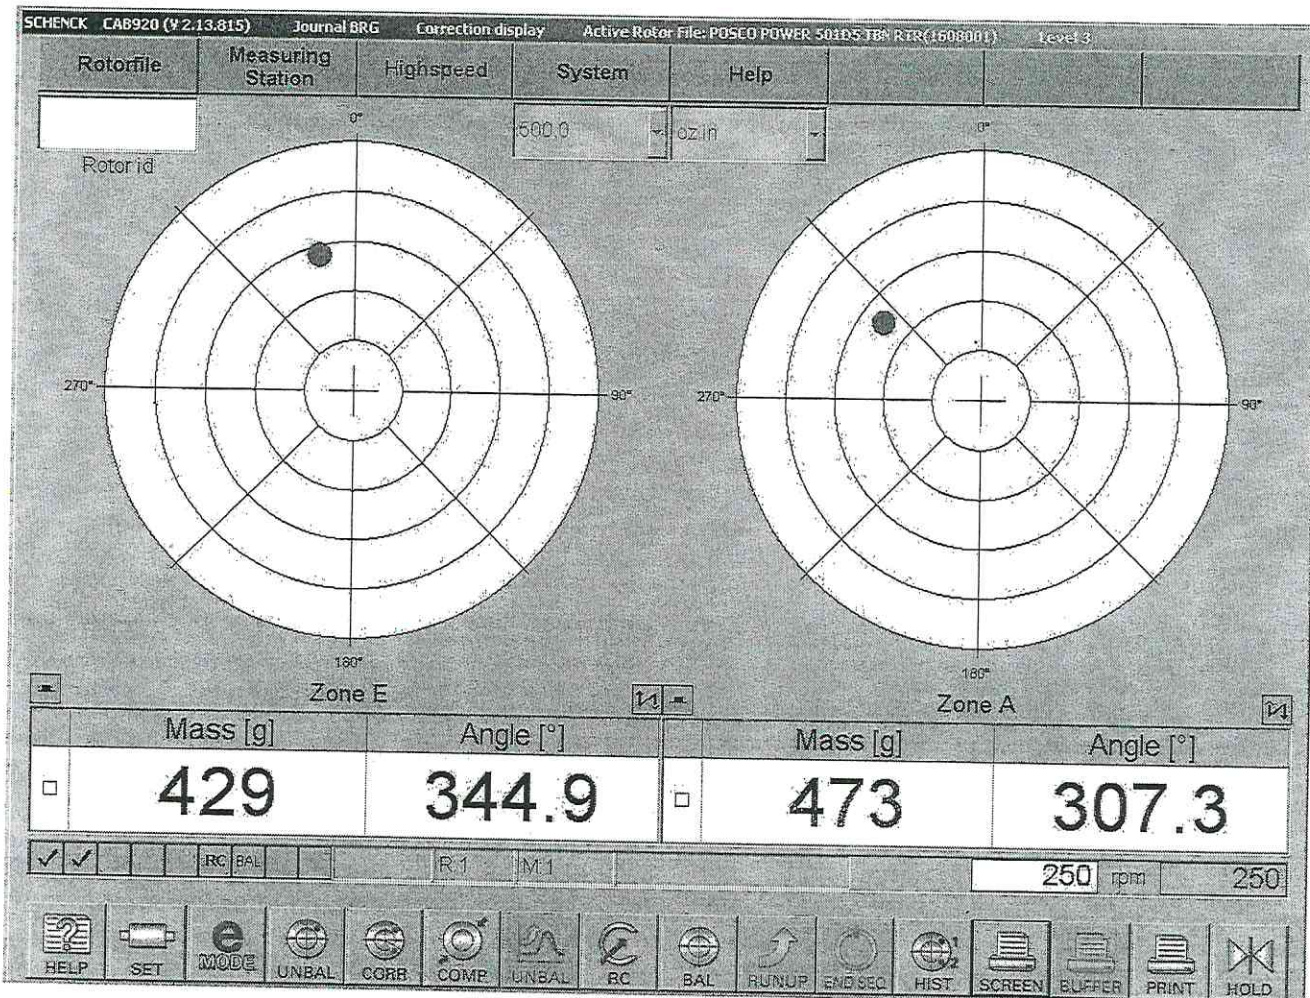
* Initial Data.

- 8.1 After having enough Bow Out procedure, the Unit Rotor without the Turbine Blades was rotated at 250 RPM and the measured Initial Total Unbalance value was 900 gram, which largely exceeds the permitted value.
- 8.2 Unit Rotor Shop Balancing procedure was performed to reduce the Unbalance value to the permitted value and the result is as found in the Attachment 4.

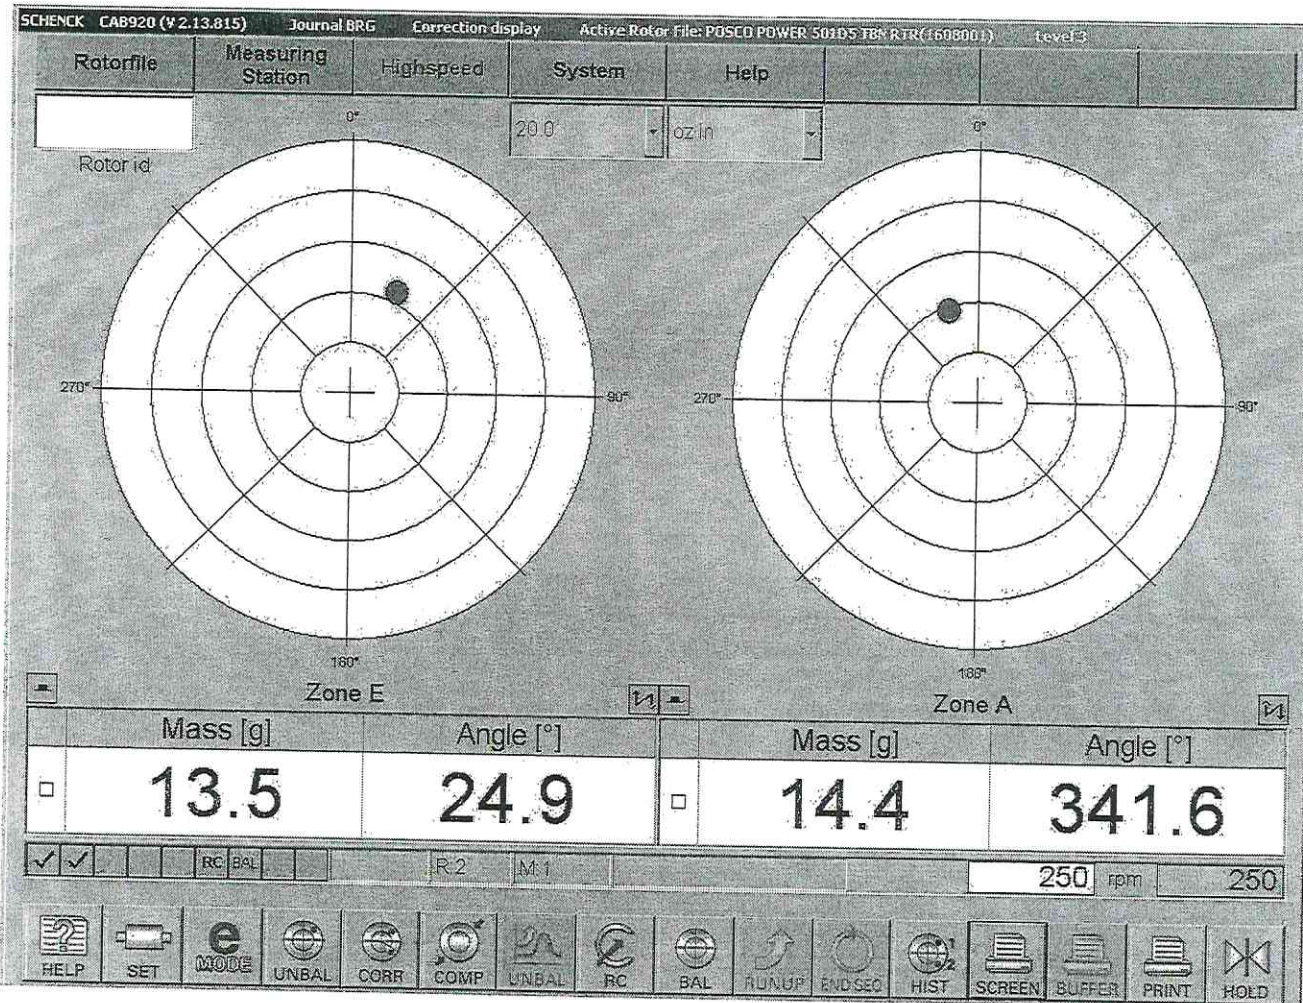
* Final Data

- Zone A : 170g Δ 286° (#10)
- Zone B : 158g Δ 325°
- Zone C : 158g Δ 324° (#9)
- Zone D : 170g Δ 322° (#6)
- Zone E : 214g Δ 7° (#1)
